# TB062 (Rev1) - Defeating Limits on an M15-6

This document describes the steps to be used to eliminate the external limit switch cables and circuitry as a cause of intermittent "\_ axis position errors" or "\_ axis full power w/o motion" errors that occur on one or more axes. It applies to the M15 models up to the M15-6.

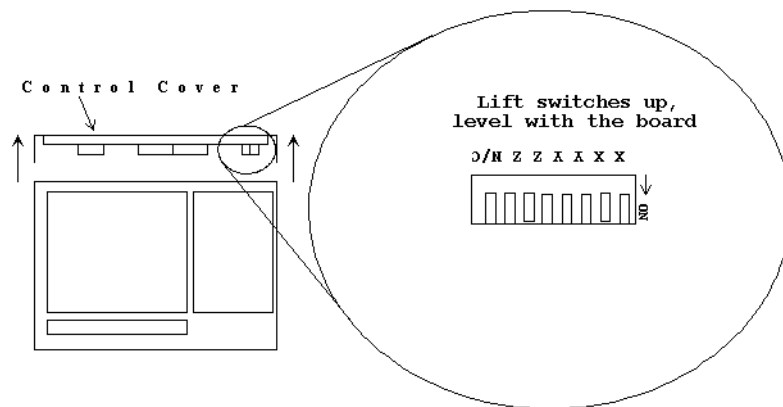
**Figure 1b (Exploded View) Defeating limit switches.**

9. Run a program until errors happen again or you are satisfied they will not occur.
10. If the errors disappear, there is a fault occurring with the switches (possibly due to vibration) or at some connection point of the limit switch wiring. In this case, refer to the technical bulletin **Isolating Limit Switch Failures on an M15**. If you are still experiencing errors, the limit switches and wires are not the problem.

5. Lift up the drive cover from the front by lifting first on the front of the cover and then pulling forward slightly. See Figure 1a.
6. Place the limit switch defeater switches in the ON position. See Figure 1b.
