TB109 (Rev1) - TOKO Cable Problem

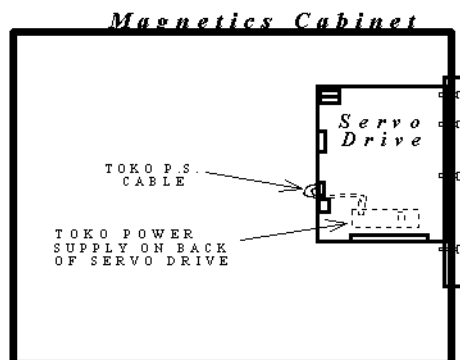
This document describes a problem that may occur on older Centroid controls that use the Toko brand drive logic power supply and have connectors on both ends of the cable. (Not soldered to the power supply).

Customer complains of jerky axis movement. While jogging, homing, or running a program.... the axis momentarily stops and then rapids a short distance to "catch up" to the position that it "should" be at. This problem will also produce an occasional "411_axis full power without motion error" on all axes. The problem is usually intermittent and seems to go away for a short time when you turn the power off and on.

The cause of the problem is a bad connection at either end of the supply cable running from the TOKO power supply to the servo drive. Over time the connection develops oxidation, which inhibits a good connection.

Remove and reseat cable at both ends (make sure that none of the pins are pushed out of place on the connector). Before reseating the cable, you should clean any oxidation off of the header connector pins. Another solution would be to eliminate the connector by soldering the wires directly to the TOKO.
