TB204 (Rev1) - Noise Problems with Dual Handwheels

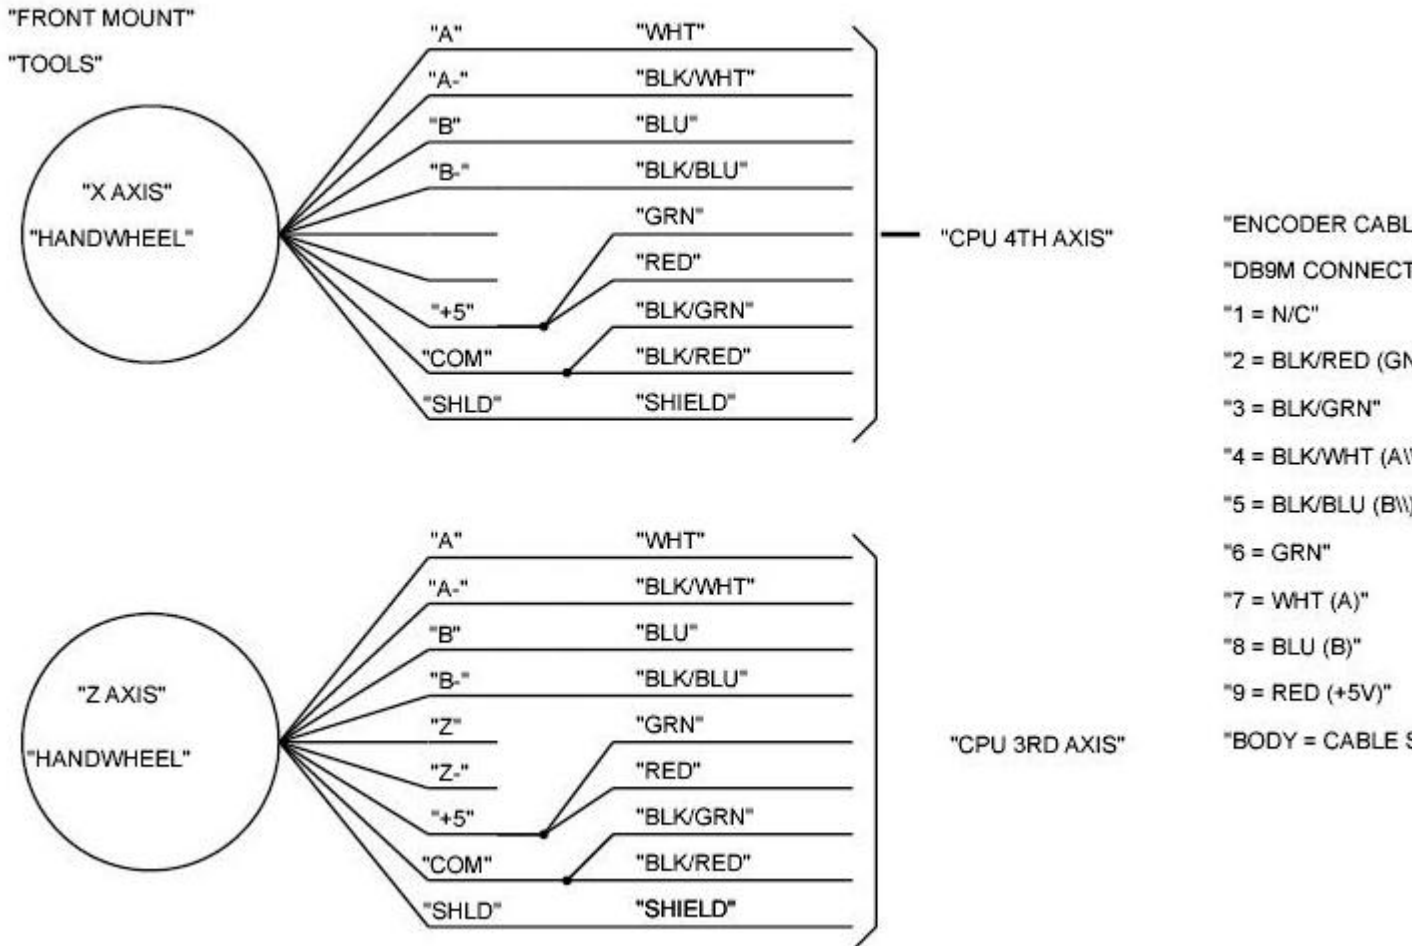
Excessive noise can be present on the index channels in a handwheel setup since the channels are not driven. The A and B signals may cross over to the index channel as well as any noise sources, causing index pulses to be detected on the CPU card. Since index channels trigger an interrupt to the DSP, the DSP can eventually be crippled by unrelenting interrupts. Tying the index pulse to a fixed state eliminates excess interrupts.

- 1 – Connect the +INDEX to VCC. The Green wire that was connected to the +INDEX (Z) is now connected to the Red wire (+5vdc).
- 2 – Connect the -INDEX to GND. The Black/Green wire that was connected to the -INDEX (Z-) is now connected to the Black/Red wire (COM).
