TB207 (Rev1) - Arm Type ATC Position Drum Problem

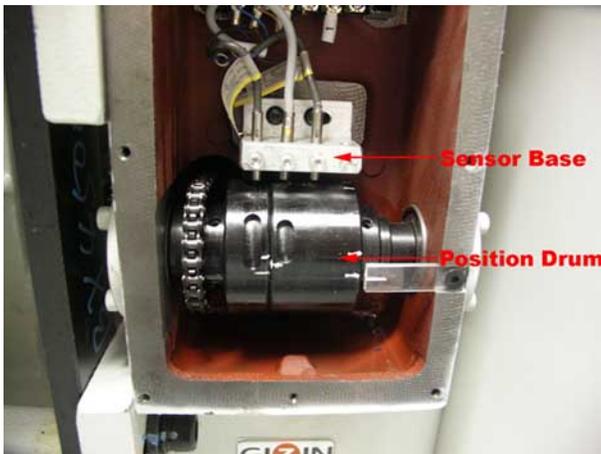
Figure 6, Position Drum and Sensors on the Swing Arm Unit

The position drum slots and sensors must be properly aligned to prevent errors. Figure 6 shows the location of the sensors and position drum; it is located at the front side of the machine on the swing arm unit. If the sensor base is misaligned horizontally with respect to the slots on the position drum, the sensors may read inconsistently. A technician can easily fix a misalignment by loosening two screws on the sensor base and adjusting sensor alignment.

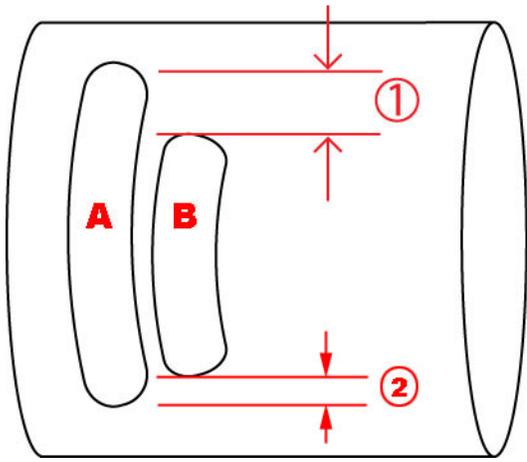
Slots on the position drum can be misaligned with respect to each other as well. The ideal position of B slot is at the center of A slot. Distance 2 can be shorter than what it is supposed to be and cause the middle sensor to trip at an earlier stage of tool change, which results in failure messages. Figure 7 shows the slot position on the drum. A technician can resolve this by reversing the phases on the arm motor. This will change the direction of the position drum rotation, which gives more time for the arm to get into the correct position before the middle sensor trips.
