TB257 (Rev1) - Fix for Intermittent Spindle Errors on Delta VFD-VE Inverters

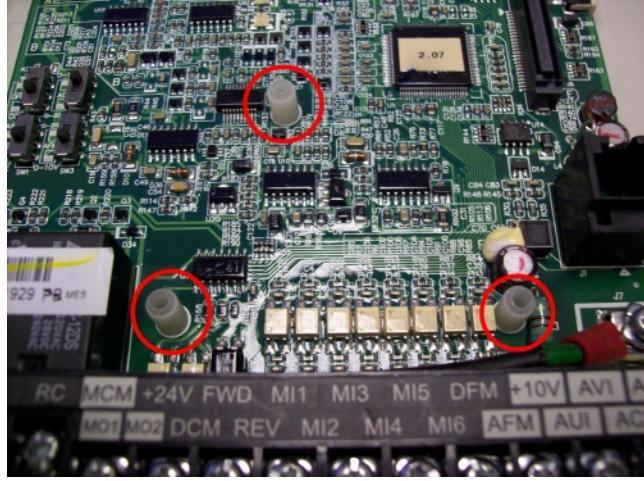
Source of the Problem: The screws used to secure the Delta orient card (PG01L/PG02L) to the main board of the inverter are the wrong size (too small). This results in the orient card not being securely held in place which leads to a poor connection between the orient card and the main board and then causes the random spindle and orient errors. The solution is to mount the card securely with larger screws so it makes good contact with the main inverter board permanently.

Picture 1: Plastic Standoffs for Orient card

3. Remove the 3 plastic standoffs from the main board. To do this, remove the 4 philips screws at the 4 corners of the main board. With the pliers, squeeze the tabs on the standoffs together and push them back through the main board.

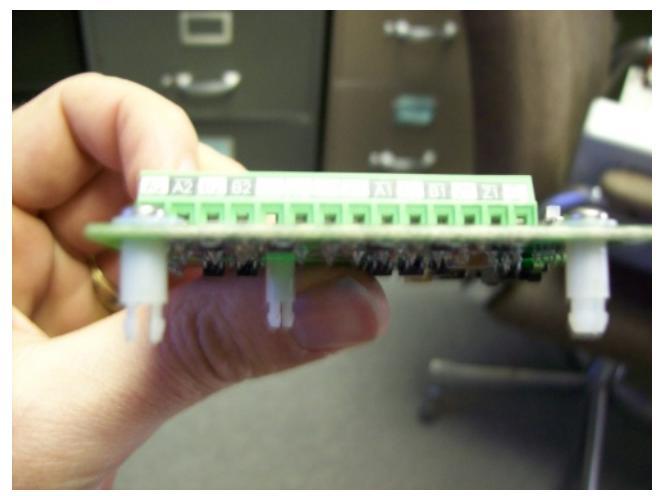
Picture 2: Sideview of standoffs mounted to Orient card

5. Now with your 4-40x3/8 screws (or whatever you have that threads into the standoffs properly) place a nylon washer against the head of the screw and thread the screw into the standoff. Repeat this step for the other standoffs.

6. Once all 3 standoffs are mounted to the Orient card, re-install the card onto the main inverter board.

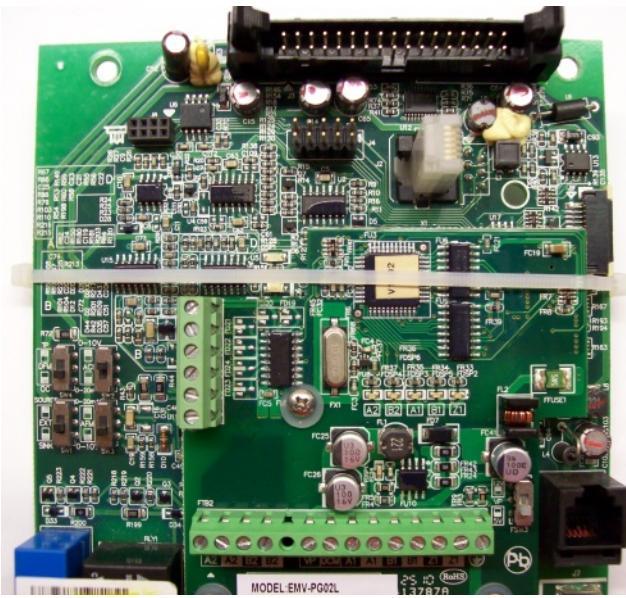
7. We have found in some cases even remounting the standoffs is not sufficient to secure the orient card due to the locations of the standoffs in relation to the connector that plugs into the inverter main board being so far apart.

Picture 3: PG-02L Orient card with cable ties installed to hold connector firmly against inverter main board.

8. In order to make sure the orient card connection doesn't come loose slide one cable tie under the main board, then connect a second one to the ends of the first one under the inverter main board. Pull both ends until the cable tie is firmly pressing down on the orient card above the connector. See picture below.
