TB056 (Rev1) - YCI-40 Spindle Damage

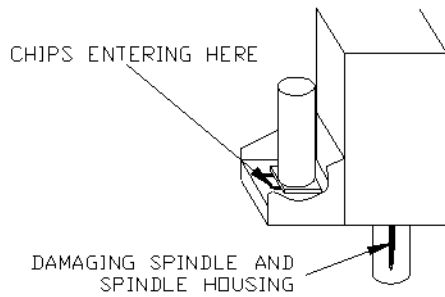
Chips can enter the motor adjustment slots on the Supermax YCI-40 knee mill and cause damage to the spindle carriage and housing, eventually making the Z-axis unreliable.

The defect can be resolved by fitting a cover over the slots or by covering the slots with silicon.
